PEMEX BURGOS GAS PROCESSING COMPLEX OPERATING AND DESIGN RECOMMENDATIONS

Gaby G. Villegas and David A. Jelf
Ortloff Engineers, Ltd.
Midland, Texas USA

ABSTRACT

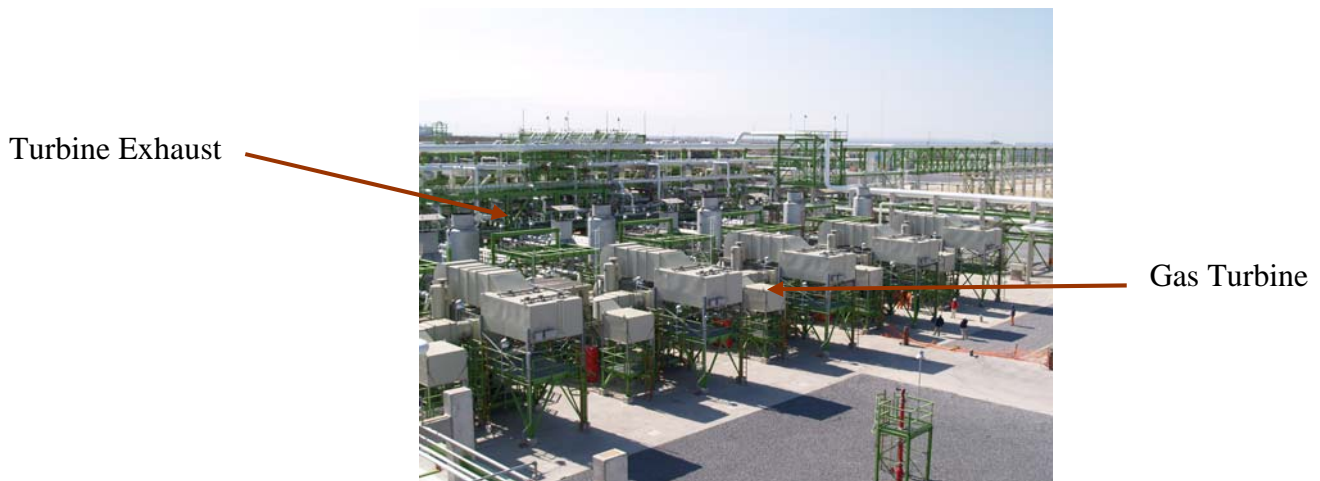
Figure 3 – Waste Heat Recovery Units on Gas Turbine Exhaust

Since water is scarce, there is no makeup water to allow using steam as the heating medium. Instead, the plants use hot oil as the heating medium for all reboilers and feed heaters. The hot oil loop includes a surge tank, charge pumps, process pumps, and waste heat recovery units on the gas turbine exhausts.
