PEMEX BURGOS GAS PROCESSING COMPLEX OPERATING AND DESIGN RECOMMENDATIONS

Gaby G. Villegas and David A. Jelf
Ortloff Engineers, Ltd.
Midland, Texas USA

ABSTRACT

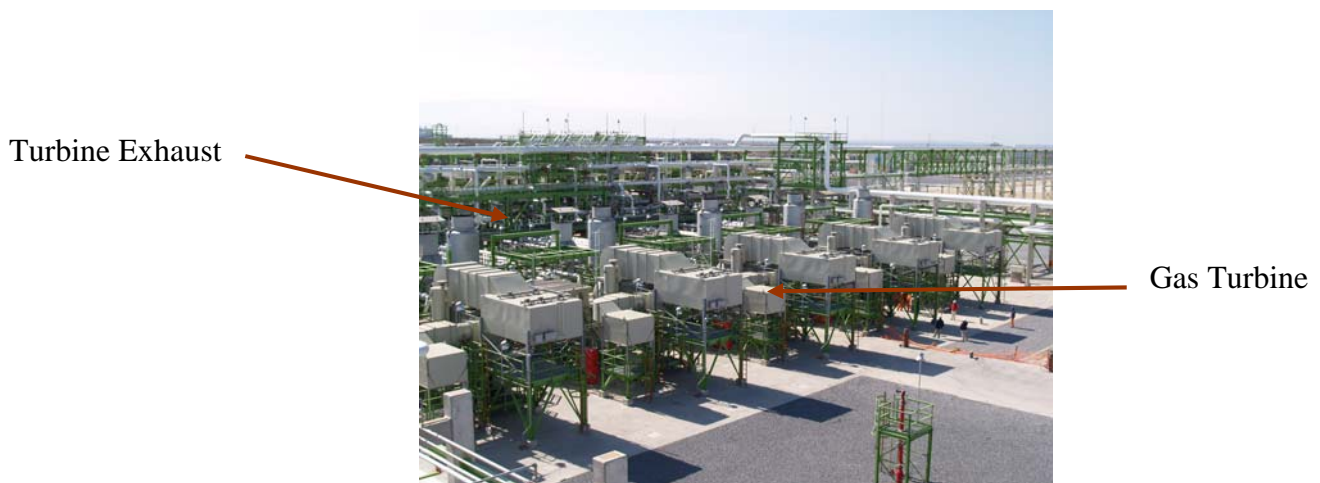
Figure 3 – Waste Heat Recovery Units on Gas Turbine Exhaust

Since water is scarce, there is no makeup water to allow using steam as the heating medium. Instead, the plants use hot oil as the heating medium for all reboilers and feed heaters. The hot oil loop includes a surge tank, charge pumps, process pumps, and waste heat recovery units on the gas turbine exhausts.

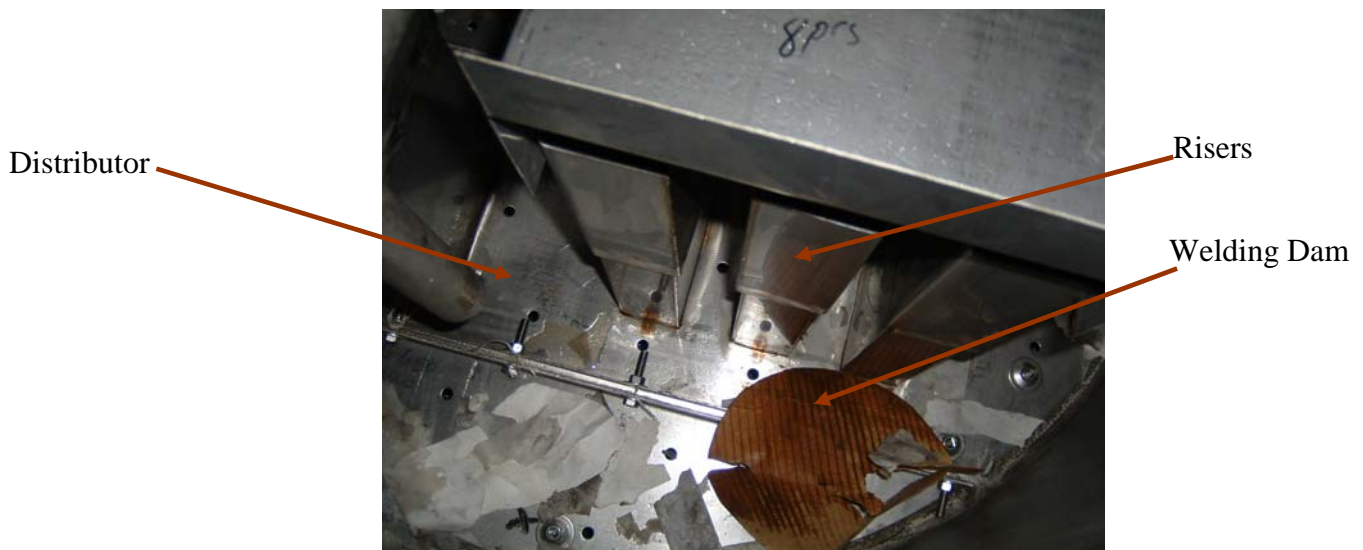
Figure 7 – Top Deethanizer Distributor

Although the temperature readings around the side reboiler improved after cleaning the strainers several more times, the tower differential pressure and temperature readings continued to oscillate. The simulation was updated to attempt to match the plant performance better. A match of the observed propane recovery level could only be achieved when the number of theoretical stages in the column simulation was reduced in both the top and bottom sections of the column.

Based on the information from the simulations and the large amount of debris previously found in the piping, the Ortloff personnel on-site concluded that debris had also entered the column and was plugging the distributors and possibly obstructing flow in the packing. The startup group decided to open the column for inspection and if necessary to clean it out. Large quantities of debris were subsequently found in the distributor trays, chimney trays, and on top of the packing (see Figure 7), and the plant was restarted after the debris was removed from these locations.
