SULFUR RECOVERY UNITS DESIGNED TO BE MORE RELIABLE

Arthur R. Laengrich
Donald N. Ewan
Chao-Hsing Tsai
The Ortloff Corporation
Midland, Texas

1977 NPRA Annual Meeting
Tuesday, March 29
San Francisco, California

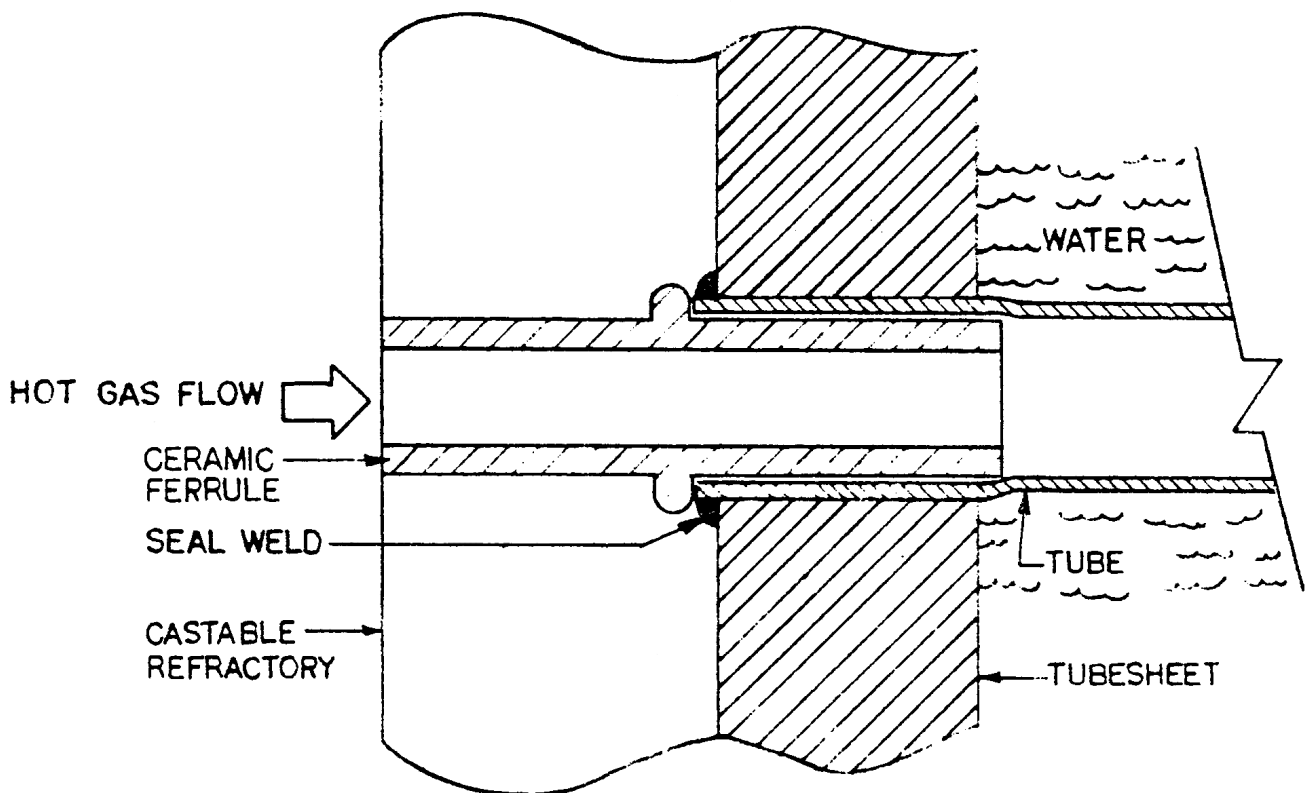
FIGURE 1
TYPICAL WASTE HEAT BOILER INLET END TUBE/
TUBESHEET TREATMENT DETAIL

At the time we began our study, we were designing the front tubesheet treatment for the waste heat boilers immediately downstream of our reaction furnaces using the general guidelines available to us. Figure 1 shows the general arrangement of tube, tubesheet, tube-tubesheet connection, and heat protection system that we used.

A carbon steel boiler tube was selected with a moderate amount of corrosion allowance. The tube was rolled into the tubesheet hole and seal welded as shown. A ceramic ferrule was installed in the tube extending slightly farther into the tube than the thickness of the tubesheet. The ferrule extended from the face of the tubesheet approximately three (3) inches. A castable refractory cover was installed over the tubesheet and around the ceramic ferrule extensions. This is a reasonably standard firetube type waste heat boiler front tubesheet treatment that has now been described and discussed by various authors. (2,3)

Since the temperature of the gases entering these waste heat boilers is typically between 2200°F and 2500°F, the potential for having extremely high heat flux to surfaces in this area does exist. As you study the patterns of heat flow to and from the surface areas, it becomes evident that the area of the tube end where the seal weld is attached has to experience the highest surface temperature. Many factors become involved in determining the temperature that will exist at this point during operation. The more important of these factors are, referring back to Figure 1:

- Thickness of the tubesheet
- Diameter of the tubes
- Spacing (pitch) of the tubes
- Resistance to heat flow through the tube-tubesheet connection
- Resistance to heat flow through the ferrule wall and stagnant gas space between the ferrule OD and the tube ID
- Resistance to heat flow through the tubesheet cover refractory
- Process conditions (temperature, velocity, etc.) of the gas flowing through the ferrule into the tube
- Degree of steam blanking that occurs at the back surface of the tubesheet and at the outside surface of-the tube just beyond the tubesheet to reduce the effective heat transfer coefficient

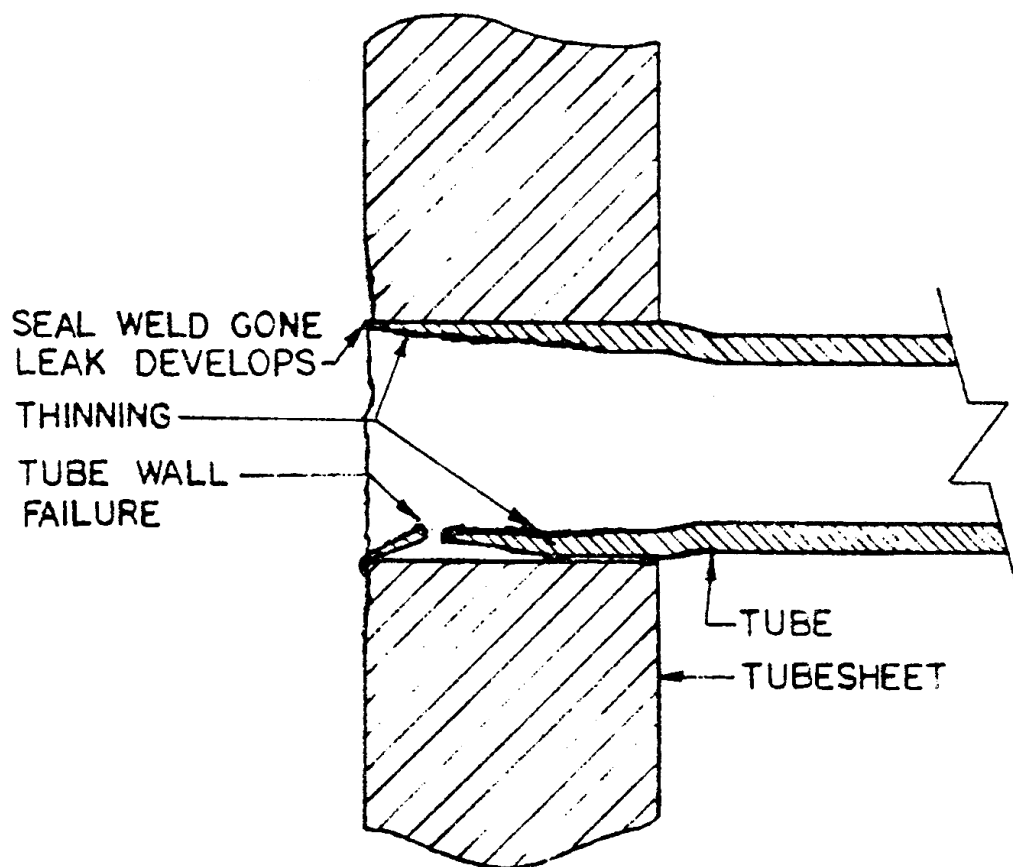
FIGURE 2

TYPICAL TUBE END DETERIORATION AND FAILURES

The more troublesome waste heat boilers we had specified, purchased and installed in our Claus sulfur recovery plants prior to 1970 had suffered reoccurring tube end failures after no more than six to eight months of operation. Several careful inspections of the failures revealed the conditions shown in Figure 2. In some cases the ceramic ferrule and refractory cover around the end of the leaking tube had been damaged severely by the leaking water. At other tubes where leaks were small or had not yet developed, the refractory cover and ceramic ferrule were removed carefully to allow a close inspection of the metal surfaces behind these heat shields. The tube end extension beyond the face of the tubesheet and the seal weld would commonly be completely gone. The tube end was very thin at the hot face of the tubesheet, with the tube wall thickness tapering to original thickness at a point somewhat inside the back face of the tubesheet. The metal would be completely gone with no significant deposit of corrosion products in its place. The leaks would be observed at one of two places, either between the tube and the tubesheet where the seal weld had disappeared or through a rupture failure in the tube wall just beyond the seal weld inside the tubesheet.

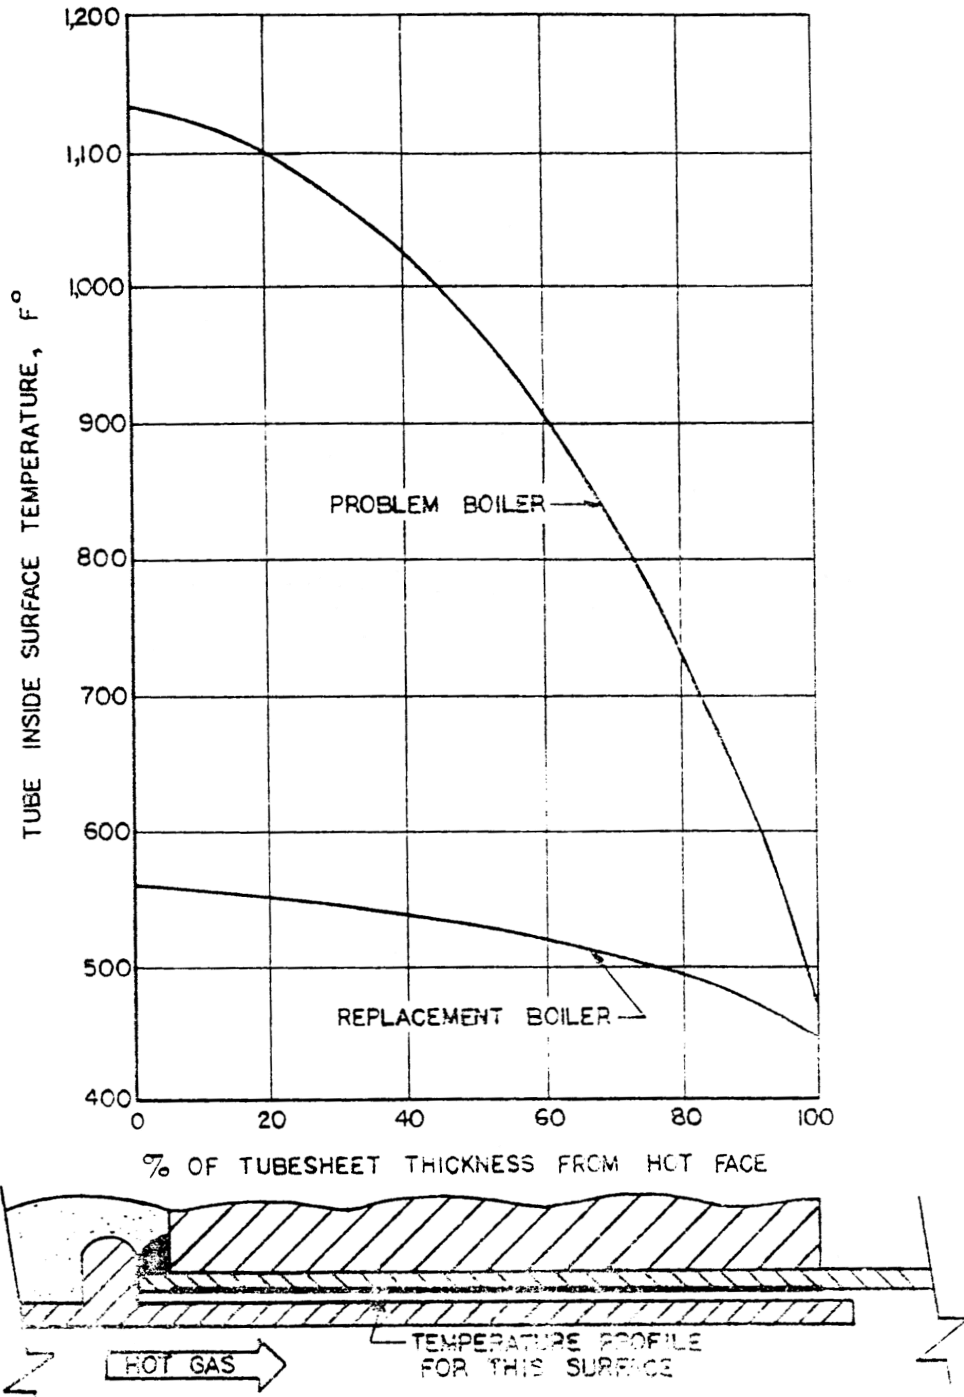
FIGURE 3

CALCULATED TEMPERATURE PROFILE FOR SEGMENT OF TUBE
HELD IN INLET TUBESHEET

The calculation model has been used to analyze several existing waste heat boiler hot end systems that experienced tube failures. A temperature profile can be calculated for the inside surface of a tube for the segment contained in the tubesheet. Figure 3 shows the temperature profile calculated for a centrally positioned tube in one existing "problem boiler" with the originally specified process and mechanical factors inputted. The tubes located in the center area of the tubesheet in this boiler had a service life of approximately six months. The model was also utilized to study the temperature profile improvement that could be obtained by changing various heat shielding and tube attachment details.

The temperature profile labeled "replacement boiler" on Figure 3 was calculated for the hot end tubesheet system specified in this design. As you can see, the replacement unit was designed very conservatively with a maximum calculated metal surface temperature of only slightly above 560°F when producing 435°F steam. The replacement unit was more expensive than the original item because it contained some 35% more surface area to accomplish the same process cooling duty. The shell volume per square foot of cooling surface was also larger, and some of the fabrication procedures were more costly. However, even a 50% greater initial cost for this one item can be very attractive additional investment if it allows long, troublefree service from the unit.

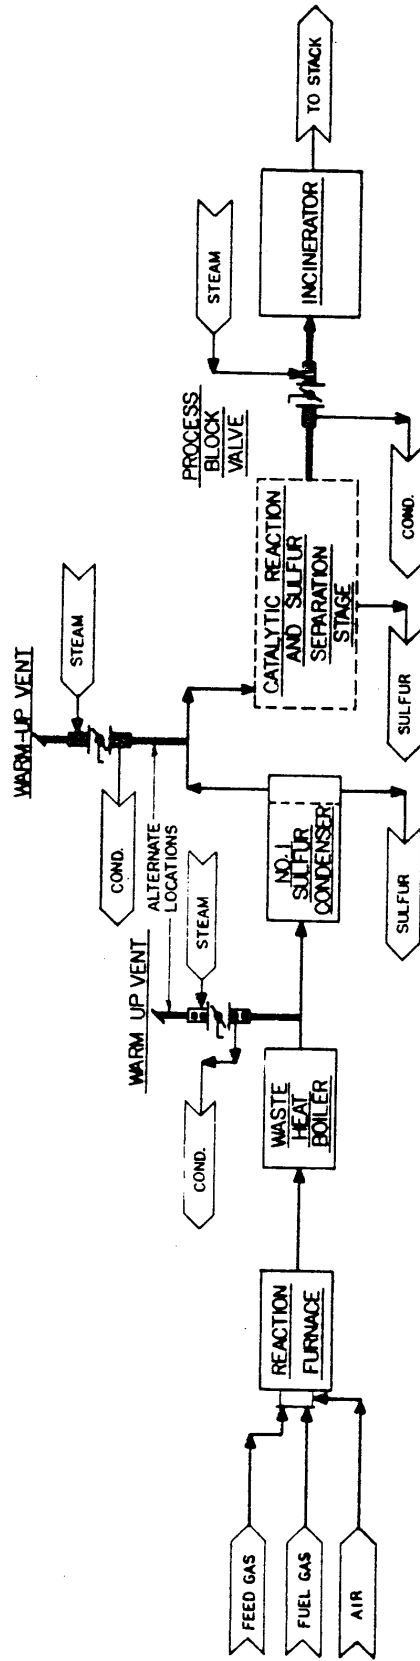
FIGURE 5
STARTUP VENT AND BLOCK VALVE ARRANGEMENT

Ortloff and others had designed a number of sulfur recovery plants with the capability of venting the fuel gas combustion products to the atmosphere upstream of the first catalyst bed. However, these venting systems typically contained valves that would never work when needed due to solid sulfur deposition and/or blinds that required pipefitter attention to utilize. Our experience told us that the typical operating group would not consistently use procedures that vented the combustion products rather than allowing them to traverse the plant unless systems were designed and installed that were reliable and easy to operate. Therefore, we developed special valve assemblies that would give long life, tight shutoff service, and easy operation. Our efforts have resulted in the use of trunion type valves with high temperature soft seats as the heart of rather special jacketed assemblies. The valves can be automatically or manually operated. We install these valve assemblies for warmup vent and tail gas line block valves at the locations shown in Figure 5.

We give design details special attention to eliminate all possible points for sulfur accumulation in equipment and piping upstream of the warmup vent location to minimize sulfur burning in this small section of the plant. We install the block valve that prevents the flow of warmup combustion gases through the plant in the tail gas line. This location is chosen because the conditions there are the most friendly with respect to obtaining long term good service from the valve. The performance of the valve assemblies we now use has been excellent. The total design of the sulfur recovery unit must be tailored in some respects to provide good "cold startup" performance. For instance, the sulfur separators must be designed to give very good droplet separation performance. Poor separator performance can allow excessive amounts of sulfur to reach the catalyst beds during the startup procedure.
